## Compliance

## Repair and Maintenance

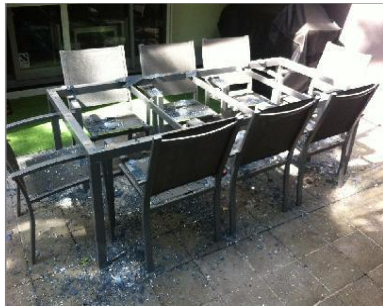
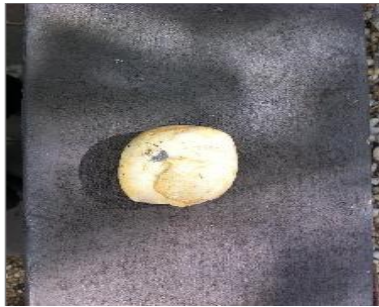
### **23/12/0201 - Smashed Glass table**

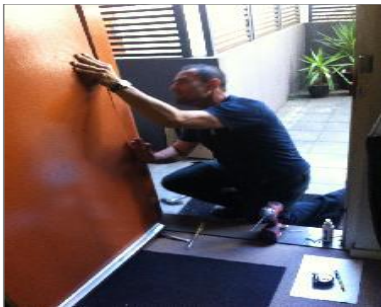
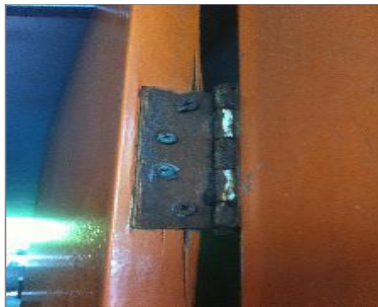
The front door of Apt. 403 was failing to close. The spine of the door where the hinges are attached were split. AFT have removed the door and filled the cracks with filler. This was an emergency fix as the front door was not able to close. The original door has been repaired and re hung . The door will need to be replaced at a future date.

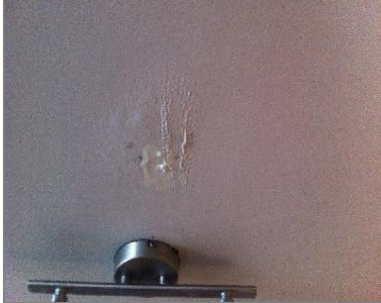
### **20/12/2013 - Leaking ceiling Apt. 330**

MRC Plumbing to investigate when onsite next.

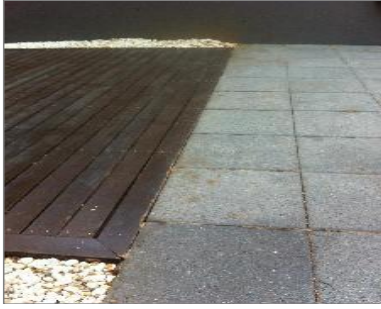
**15/01/2014 - Raised lip on timber deck Apt 202 - trip hazzard**

Raised lip on timber deck Apt 202 has been levelled and is no longer a trip hazard.

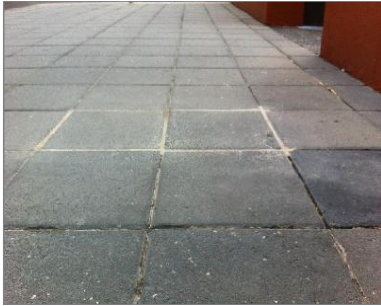
**15/01/2014 - Sunken pavers - trip hazzard near Apt 401**

4 x sunken paver's have been levelled as per solutions in engineering recommendations report.

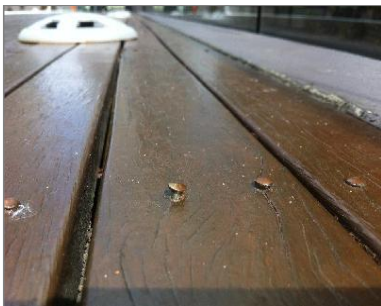
**15/01/2014 - Protruding nails in from timber deck in pool area**

The building manager has removed any protruding nails from the swimming pool deck and replaced them with decking screws. The decking is now secure with no protruding nails.

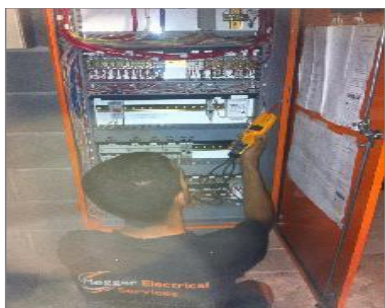
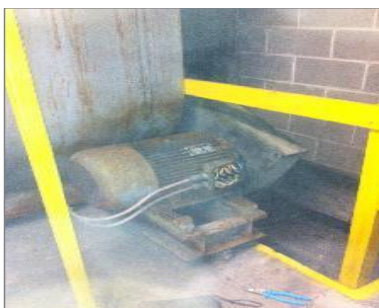
### **11/02/2014 - Exhaust Fan - Garbage exhaust plant room**

Once the fault has been identified and repaired, as per MRC Plumbings advice, a roof should be installed on top of the exhaust fan outlet shaft to prevent water entering the shaft and entering the garbage exhaust plant room and damaging the exhaust fan. TBA

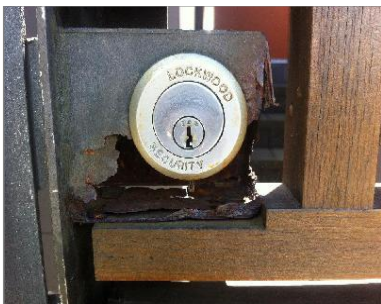
The gate lock housings on ground floor apartments are rusting. Building manager to count the number of rusted gate lock housings and engage contractor. St Peters Engineering will be onsite on the 13th Feb. 2014 to begin the lock box replacement.
