**Integrated Building Consultancy Norwest**

23 April 2014

*Our ref: 2140076-REP*

**RE: SP69259 - MONDRIAN 2 POWELL STREET, WATERLOO NSW 2017**

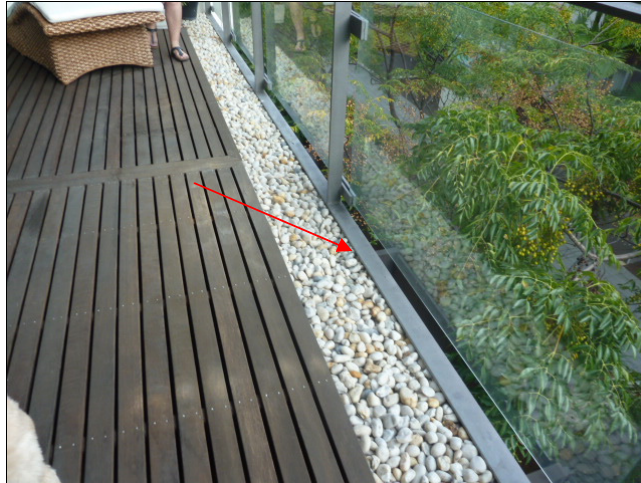
### Unit 331. Building 3.

The style of Balcony balustrade found at this unit is classified as glass finishing above the pebbles.

The balcony is partially covered with a timber deck which is bordered by white/light coloured pebbles of various sizes. The pebbles are laid loose on three sides of the balcony directly onto the slab to a depth of approx 75mm. In general, the pebble finish is level with or slightly above the rail edge (arrowed). There is a gap of approx 50mm between the upper edge of the rail and the glass panels.

I was informed by the unit occupant at the time that there had been no issues with pebbles dropping from this balcony either by accident or through deliberate intention. I was further informed that as far as she had been aware, there had been just two incidents over the past few years where Pebbles had fallen from a balcony within the complex. It is understood that one incident was by accident and the other through a deliberate act however I was unable to confirm this.

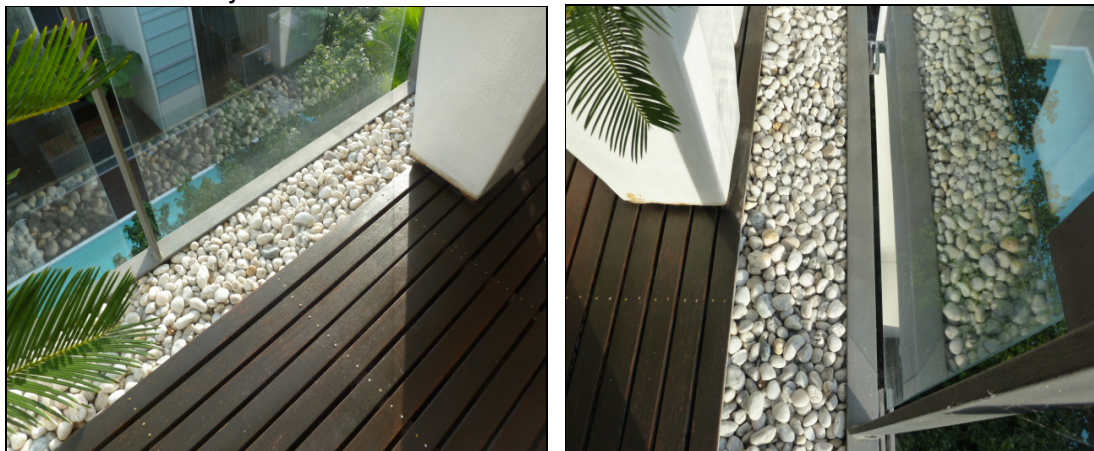
### Unit 352. Building 3.

The style of balcony in this unit was found to be a design where the glass balustrade finished down below the front edge of the balcony slab.

As per the previous unit, the balcony is covered with a timber deck bordered by the pebbled finish on three sides. The description of the pebbles location, depth and size remained consistent with that noted in the previous unit.

The unit occupant stated that there had been no incidents with pebbles falling from

this unit's balcony.

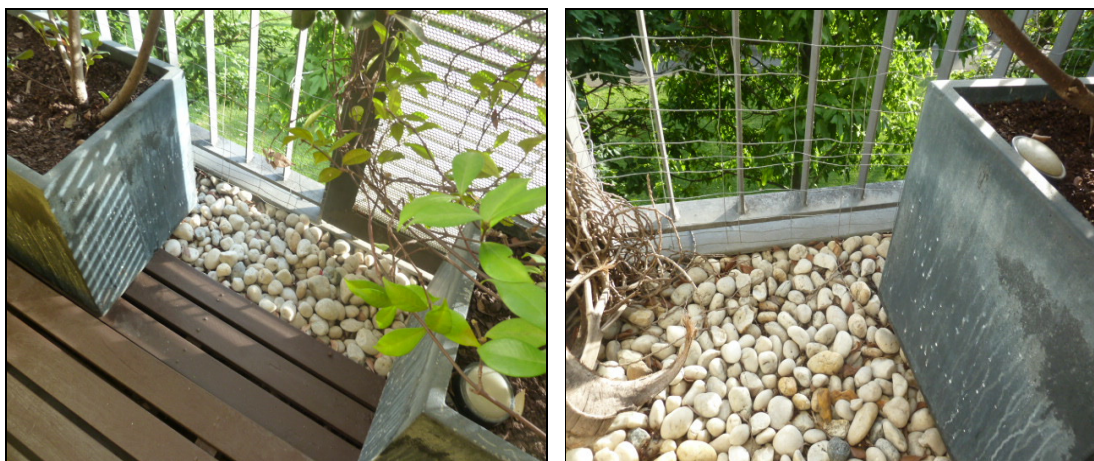
#### **Unit 412. Building 4.**

The balustrading on this unit's balcony consisted of metal fence railing which finished approx 50mm above the level of the pebbles and above the front edge of the balcony slab. The railings of this unit were also covered with a wire mesh for approx 400mm height across the full width of the balcony. I am informed that this was to prevent the small dog from slipping through and had no relation to the pebbles. The unit occupant informed me that there had been no issues with pebbles falling from this balcony.

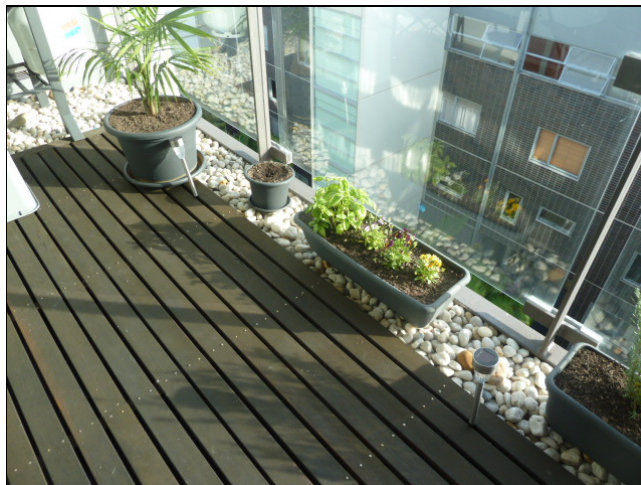
#### **Unit 359. Building 3.**

The style of Balcony balustrade found at this unit is classified as glass finishing above the pebbles, the same as Unit 331. There is a gap of approx 50mm between the upper edge of the rail and the glass panels. The pebbles are mostly slightly lower or level with the external edge rail.

I am informed by the unit occupier that there have been no issues as far as she is aware with pebbles falling from this location since she has been in residence.

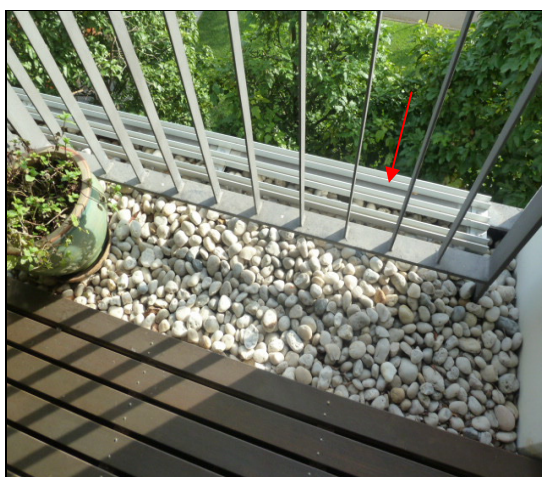
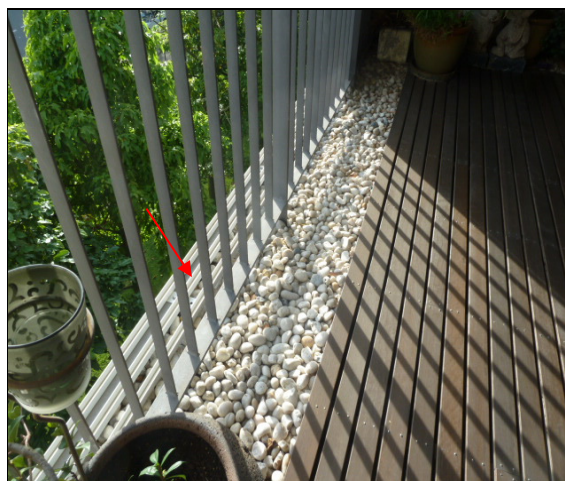
#### **Unit 418. Building 4.**

The balustrading on this unit's balcony consisted of Metal fence railing which finished approx 50mm above the level of the pebbles, similar to that of Unit 412. The difference in this case being the additional installation of a shuttered variation on the edge of the slab. (Arrowed). This prevents any pebbles from being accidentally kicked off this balcony. It should be noted however, that this configuration/design alters from the others inspected so far and it is unlikely that this solution (should it be considered) would be an option on the majority of the remaining balconies.

There are no reported incidents of pebbles falling from this location.

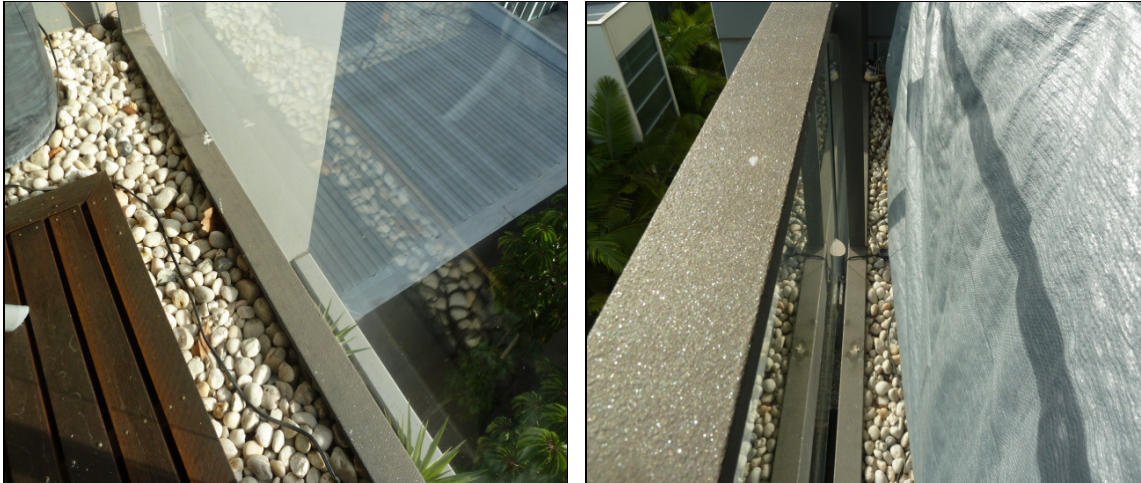
## Unit 215. Building 2.

The final unit scheduled for inspection had concurrent works underway. This restricted the area of the balcony for viewing as it was mostly covered with furniture.

The balustrading design was the same as that noted on Unit 352, the glass balustrade finished down below the front edge of the balcony slab.

The occupant was not available for comment and access was provided by the Building Management.
